A TowerScan in a Different Plane

Horizontal Scans on Reactor-Internal Riser: East - West

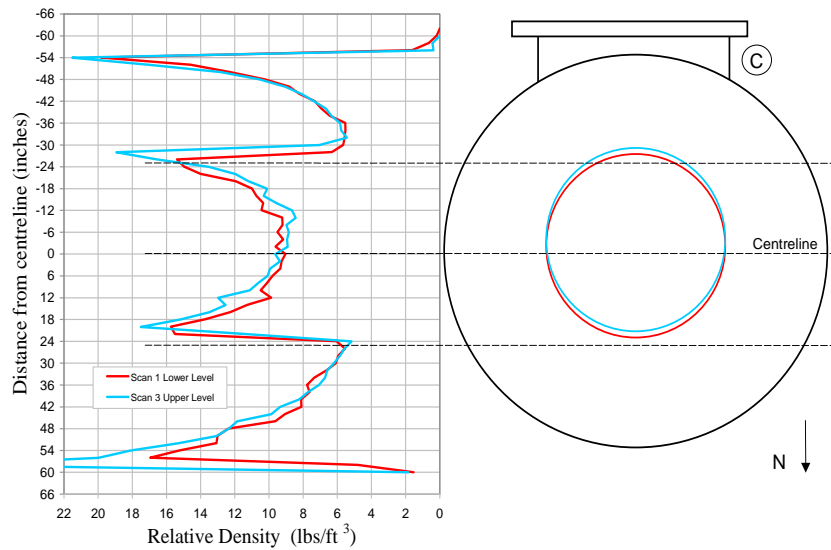
Horizontal Scans on Reactor-Internal Riser: North - South

If the riser was undamaged and in position, the density profiles should essentially be that of a smaller empty pipe (the riser walls), centered on, and superimposed upon a larger empty pipe (the drum walls). The scans indicated that the internal riser had in fact been broken off. The density profiles indicated that the top of the riser was leaning against the west wall of the drum, offset slightly to the south of the east-west centerline. Armed with this knowledge, process operations determined that with additional precautions they could continue operating the unit until the next scheduled shutdown.
