## Profiles of Normally Operating vs. Damaged Trays

Example of a Tower with Tray Damage

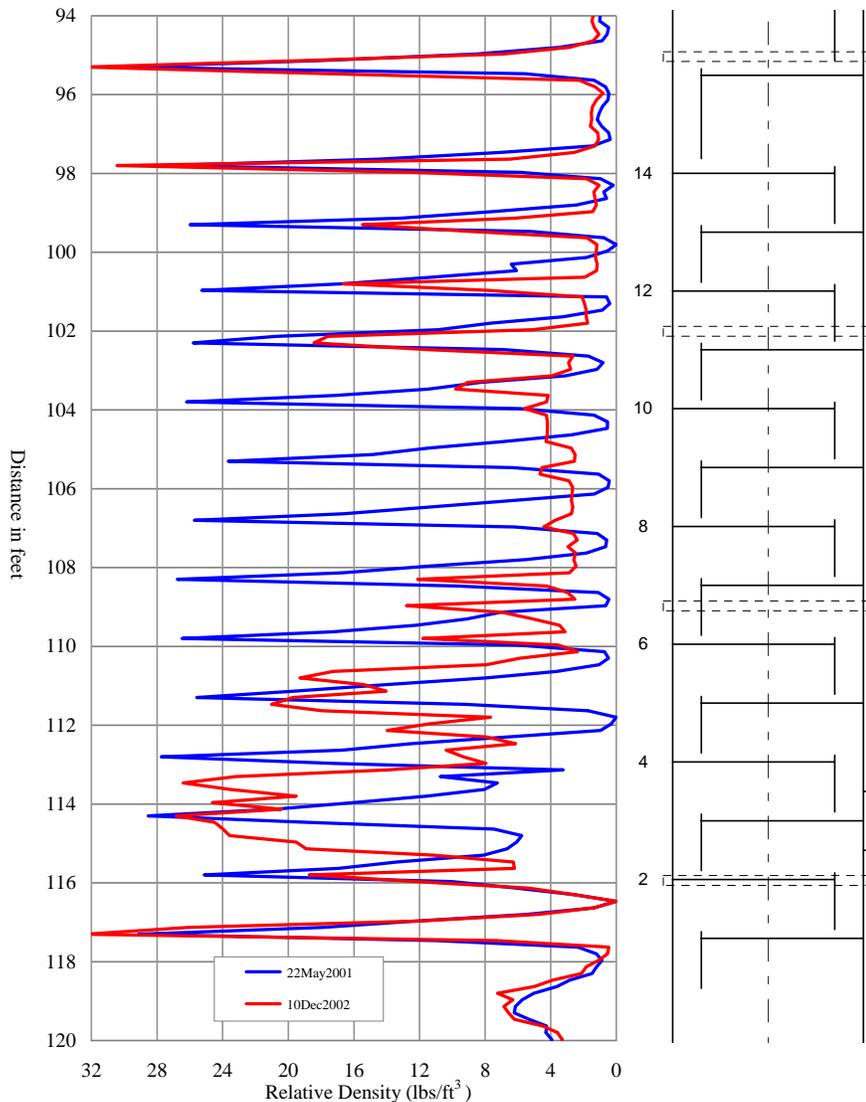
**TowerScan Results:** The most recent scan plotted in red, revealed that the tower had suffered extensive damage to trays 2 through 13. The damage was easily identified, especially when compared to the blue profile showing normal operation a year earlier.

Knowing which trays were in need of repair, the customer was able to pre-order tray parts and arrange to have sufficient labour on hand in order to minimize their downtime.
