## Neutron Backscatter - Multiphase Level Measurement

### Neutron Backscatter - Multiphase Interface Level Measurement

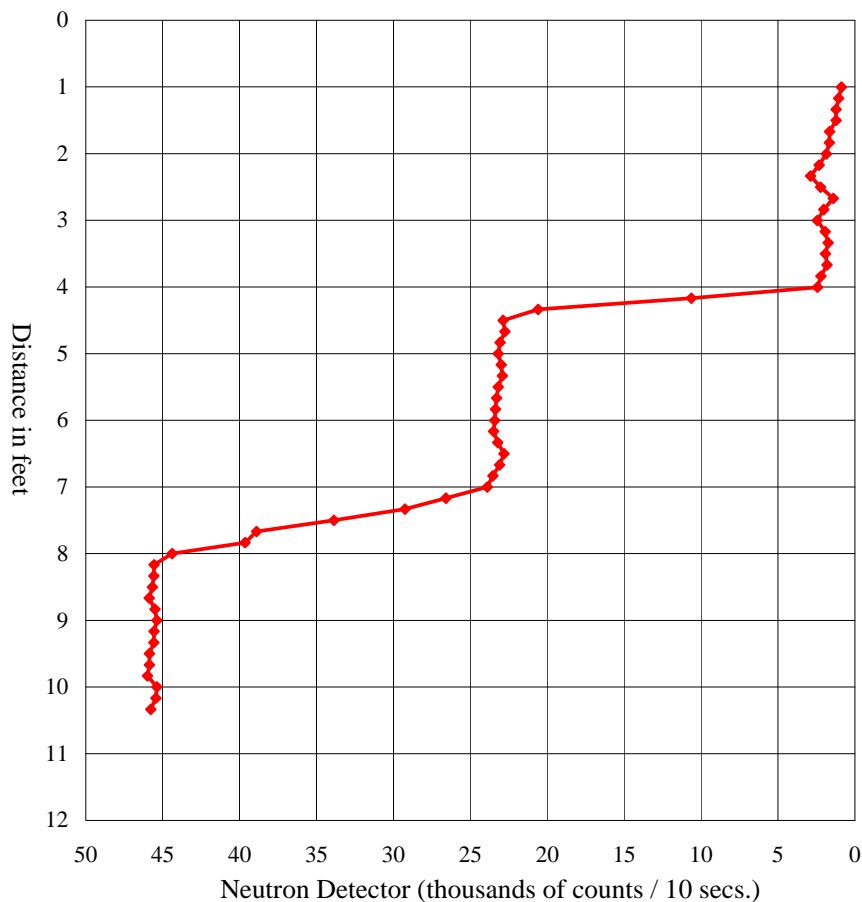
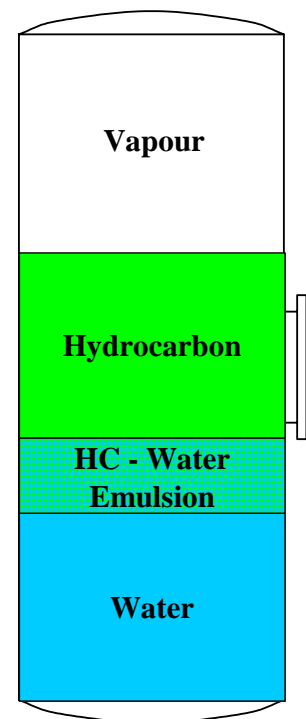
**Pre Job Info:** The customer had a vertical drum which contained multiple phases - vapour, hydrocarbon, an emulsion phase, and water. There were both high and low level nucleonic level indicators installed on the vessel, the problem was that simultaneous high and low level alarms were being indicated.

**TowerScan Results:** TowerScan performed a series of neutron backscatter surveys at different process conditions, one of which is shown. This allowed the customer to recalibrate their installed nucleonic instrumentation.

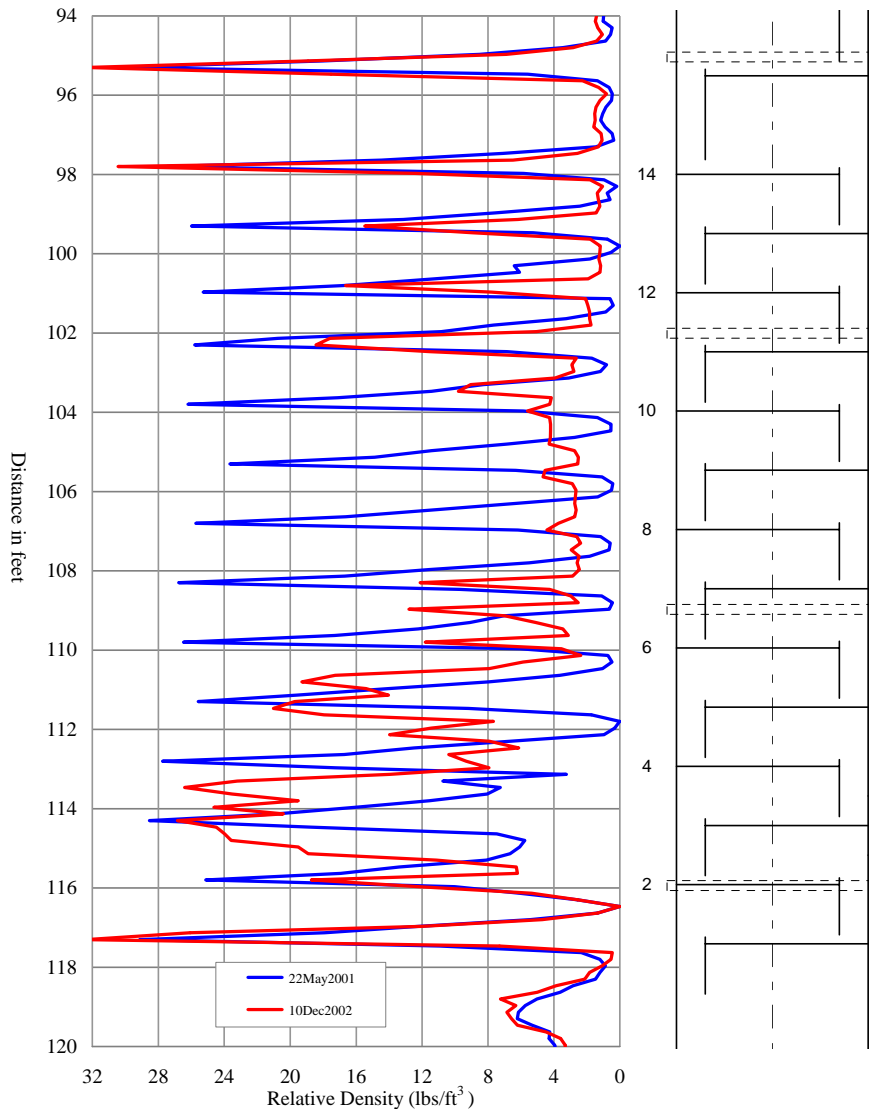
Example of a Tower with Tray Damage

**TowerScan Results:** The most recent scan plotted in red, revealed that the tower had suffered extensive damage to trays 2 through 13. The damage was easily identified, especially when compared to the blue profile showing normal operation a year earlier.

Knowing which trays were in need of repair, the customer was able to pre-order tray parts and arrange to have sufficient labour on hand in order to minimize their downtime.

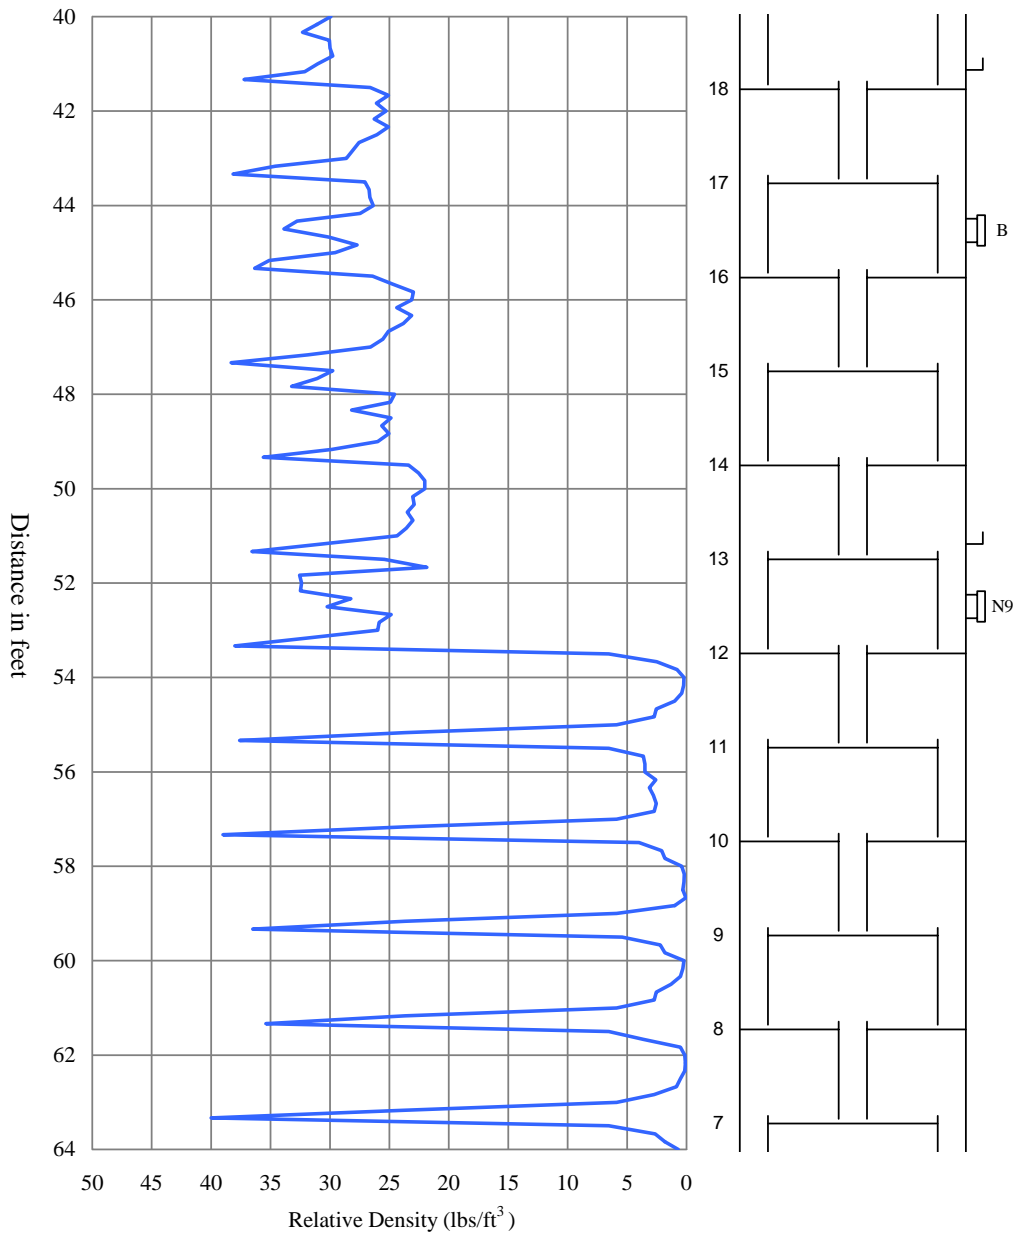
Example of a Mechanical Obstruction Resulting in Flooded Trays

**TowerScan Results:** The scan revealed the tower to be flooded from tray 12 upwards. The sharpness of the transition from a flooded condition to a normally operating tower above and below tray 12 indicated an obstruction in the tray 12 downcomer. As the tower had a history of solids (salts) building up on the trays, the customer performed a water wash of the tower, after which the tower's operation returned to normal.

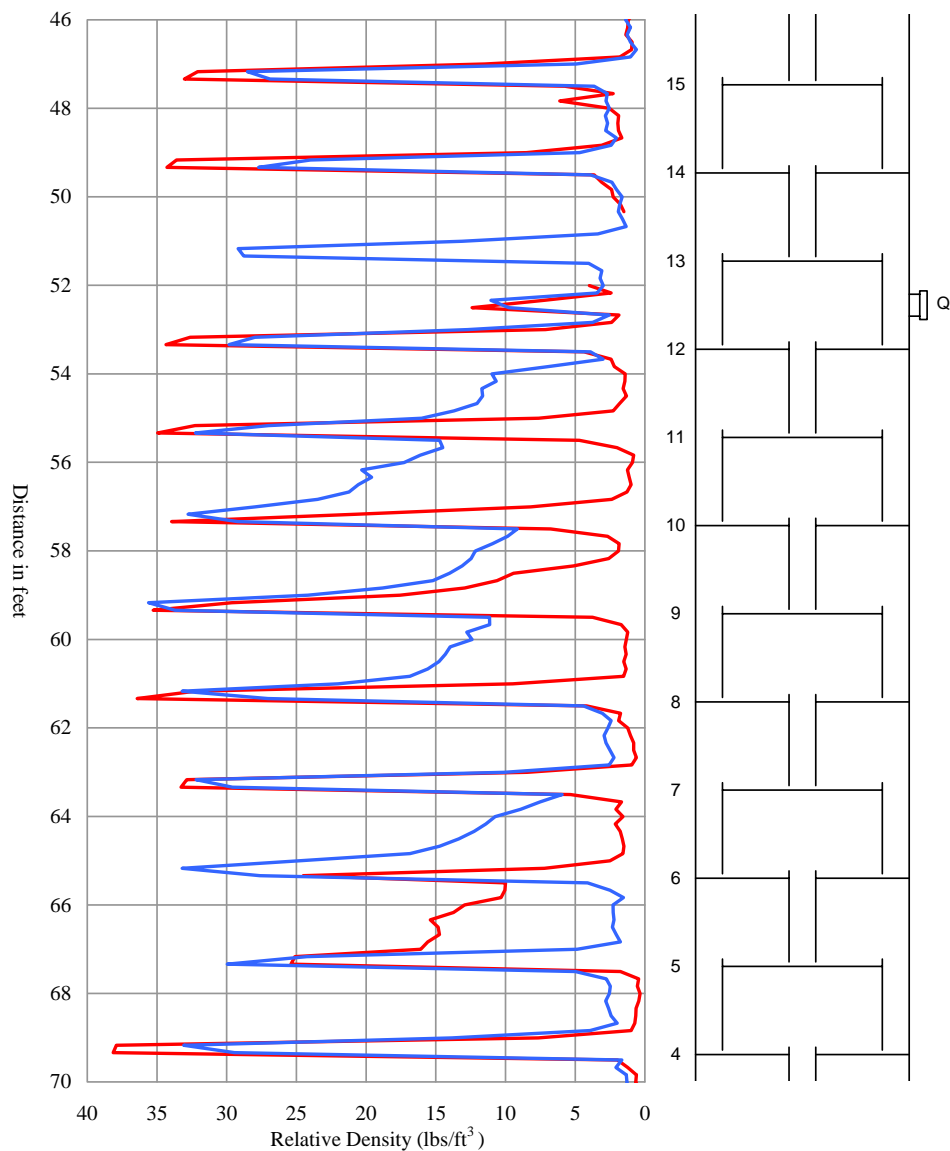
Foaming: Optimizing Use of Anti-Foam

**TowerScan Results:** A series of scans were performed with changing amounts of anti-foam being injected. Gradually decreasing the volume of anti-foam, the red scan showed foaming just starting to develop. The next reduction in anti-foam volume showed a significant increase in the number of trays experiencing foaming, thereby allowing the customer to determine the threshold level of anti-foam that would allow them to maintain stable process operating conditions and minimize cost.

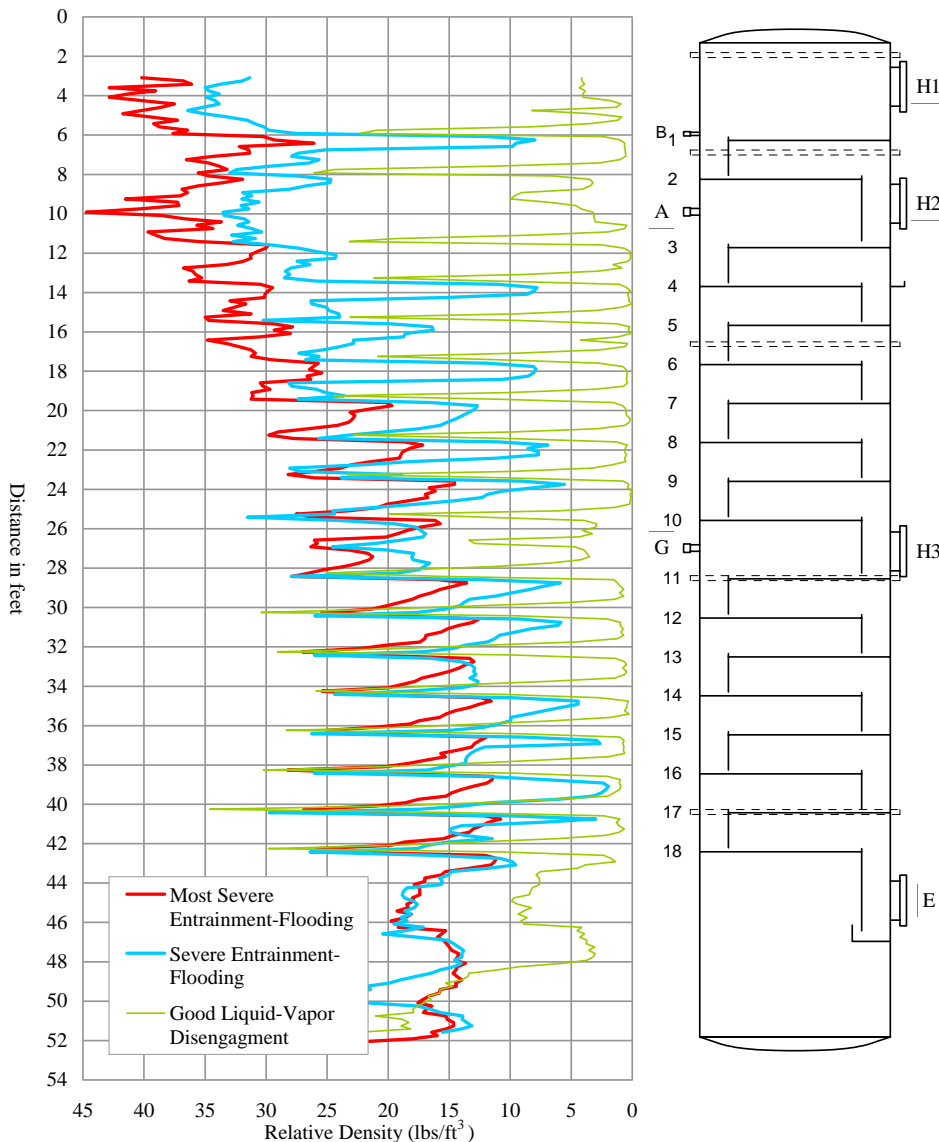
Entrainment - Jet Flooding in a Trayed Column

**TowerScan Results:** The first scan (plotted in red) revealed the trays to be severely entrained and in a "jet" flood. In addition, the base liquid level appeared was highly aerated and above the vapor inlet, almost reaching the bottom tray. As changes were made to the tower's operating conditions, especially the reboiler and base liquid level, the process personnel were able to eliminate the entrainment (green plot) until the tower was operating in a stable manner at the "new post turnaround normal conditions" and the product was on specification.

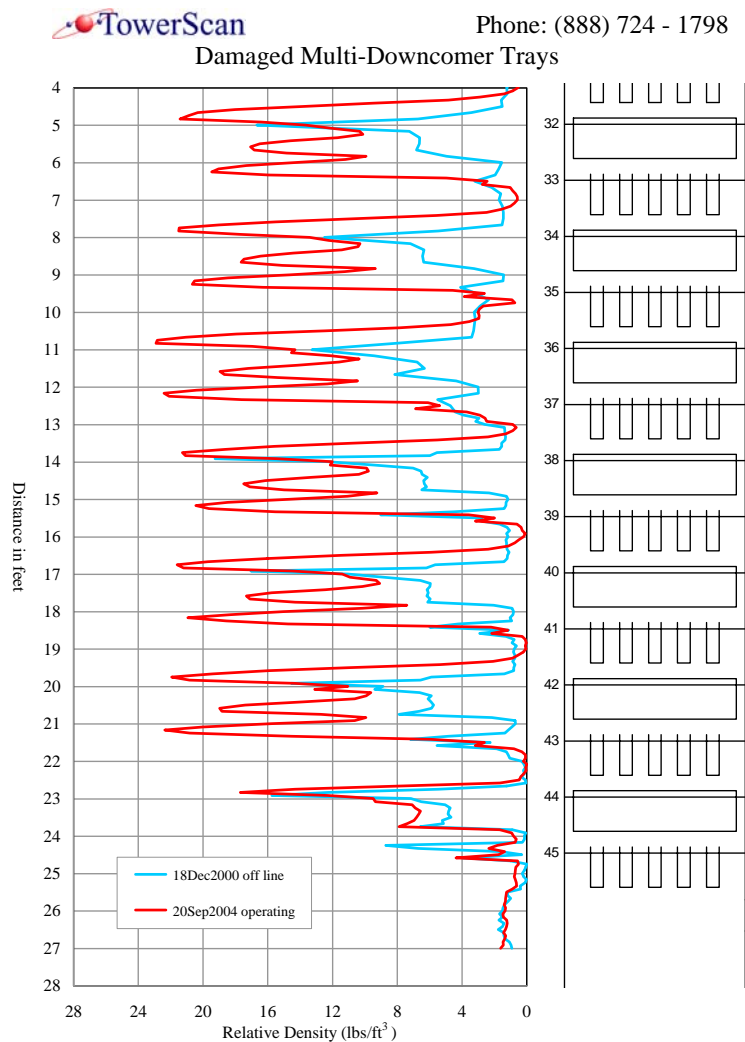
TowerScan had performed a baseline scan on the same tower, offline, four years earlier (blue plot). The current scan in red revealed that the bottom tray (45) was missing, and the next tray up (44) was severely damaged. With this knowledge the engineer was able to adjust the operating parameters in order to manage the damaged tower in the best way possible. In addition, they were provided with adequate planning time for them to go into the tower during their next shutdown, which was less than a month away, knowing what had to be fixed.

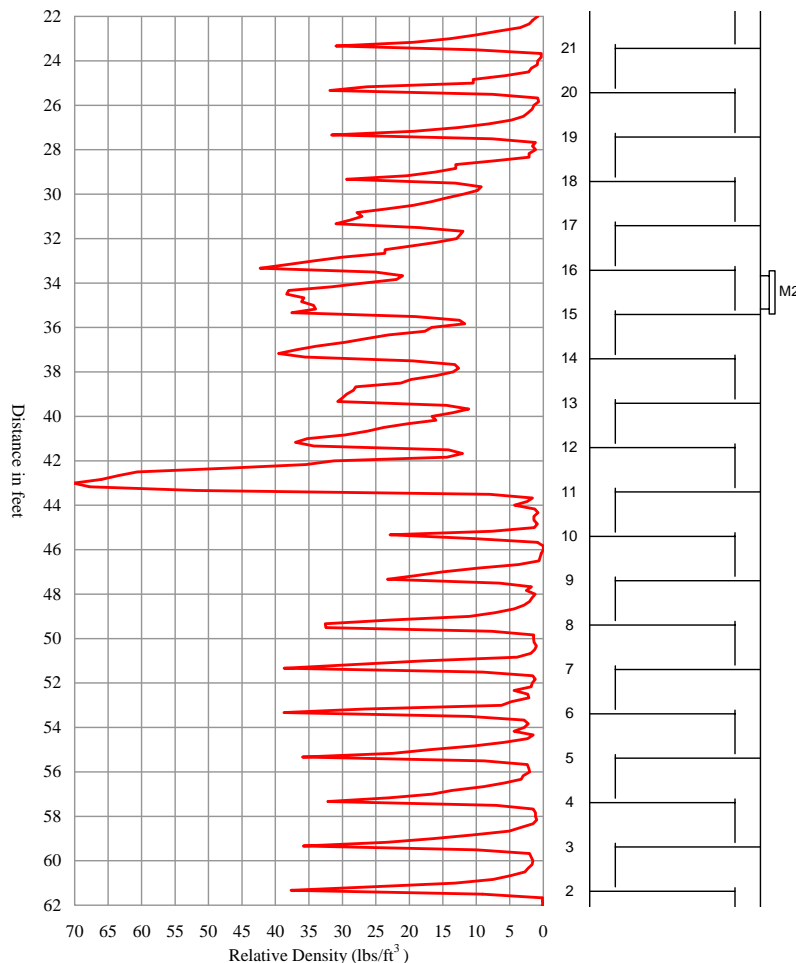
Minor Damage Resulting in Vapour Bypass up the Downcomer

**TowerScan Results:** The rates were reduced in order to obtain a scan under stable operating conditions. The first scan showed trays in the middle of the tower (11-17) to be flooded, with evidence of entrainment on the trays higher up the tower. The unusual aspect of the scan profile was the extremely high density seen for the liquid on tray 11. Given that tray 11 was holding liquid, and therefore mechanically sound, TowerScan personnel were confident in predicting that the vapour was bypassing the tray via the downcomer, as there was no aeration of the liquid.

The mechanism causing the vapour bypassing wasn't 100% certain from the profile. Trays 10 and 9 immediately below 11 showed reduced liquid loadings on the tray. Typically this is due to damage, however the possibility of the trays from 11 upwards loading up with liquid and then dumping, temporarily starving the trays below of liquid remained as an alternative explanation.

Subsequent inspection of the tower revealed that the tray deck panel immediately underneath the downcomer from tray 11 was damaged. As such it allowed the vapour to bypass tray 11, and most of the liquid to bypass trays 10 and 9 even though the remainder of that decking was mechanically sound.

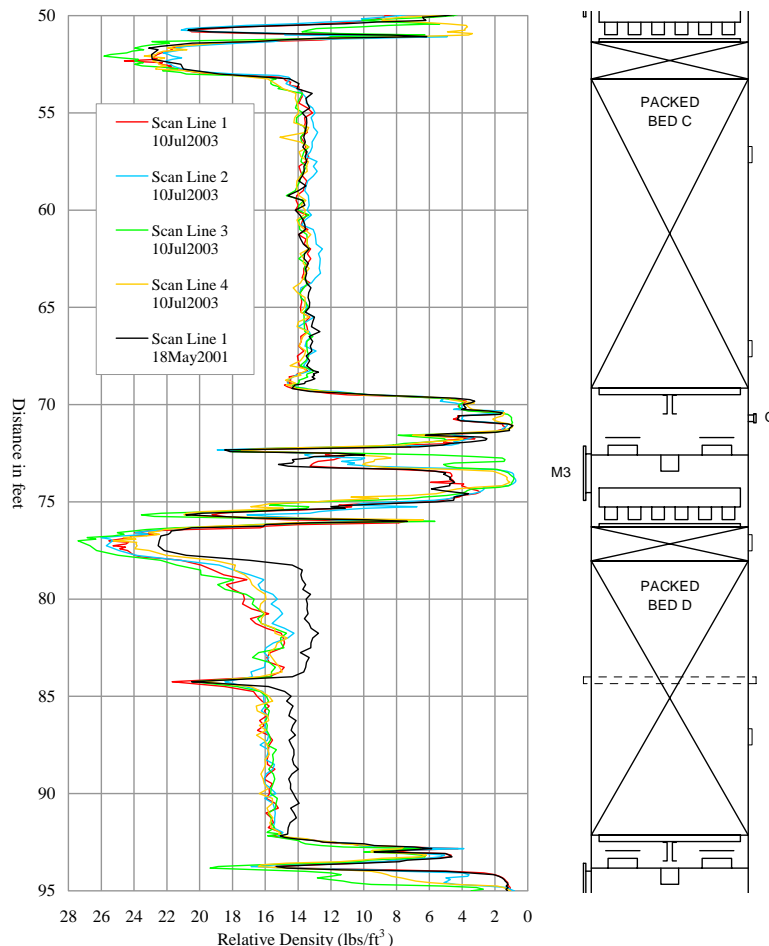
Phone (888) 724 - 1798  
 Packed Beds: Baseline Scans Used for Shutdown Planning 2 Years Later

**TowerScan Results:** The adjoining scan profile shows the grid scan performed two years after the baseline scan, as well the profile (black) for one of the four baseline profiles. Each of the six packed beds consisted of a shorter section of structured packing in the top of the bed, with the majority of the bed consisting of dumped packing.

The greatest contrast was between the two beds shown, beds C and D. While all of the beds showed some fouling in the smaller structured packing element at the top, the remainder of the beds, consisting of the dumped packing, were seen to be still operating with a uniform density profile, clear of significant fouling. The exception was bed D below the feed inlet, which showed appreciable fouling throughout the bed. Armed with this knowledge going into the shutdown, the unit engineer was able to minimize the downtime by planning to clean the distributor above each bed, as well as the top structured packing element, while leaving in place all of the dumped packing except for that in bed D which was replaced.

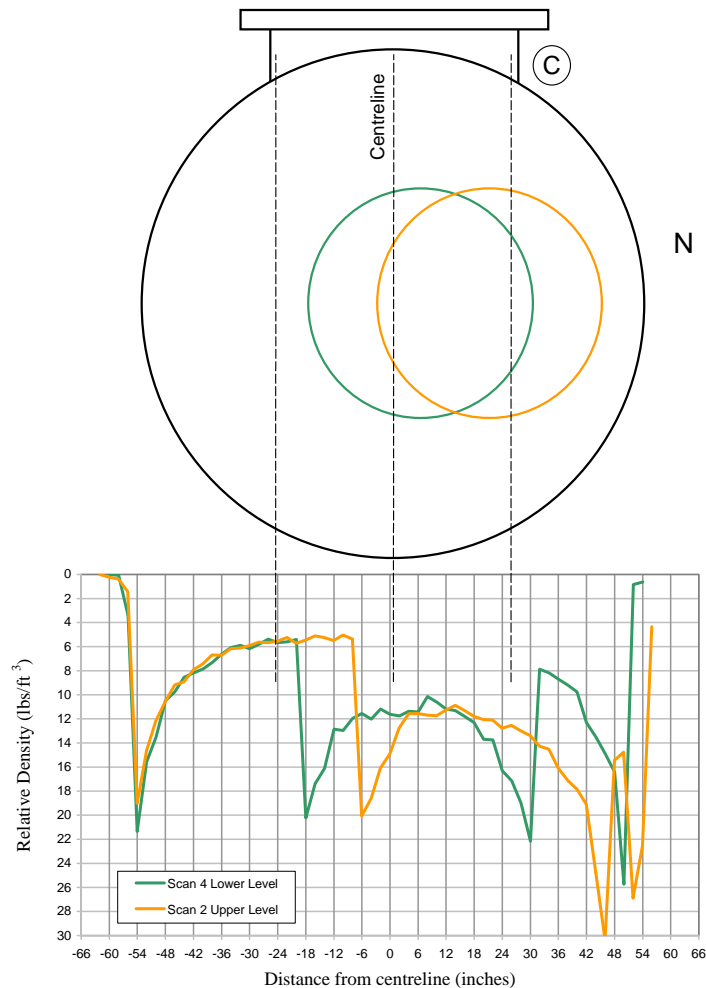
Horizontal Scans on Reactor-Internal Riser: East - West

**TowerScan Results:** The scans were conducted by erecting a square horizontal framework of scaffolding poles at two different elevations. The source and detector were suspended from the scaffolding frame and then positioned so that they were past the edge of the drum, i.e. there was nothing between the source and detector. The source and detector were then moved in two inch increments, horizontally, to in effect take a cross-sectional cut of the disengagement drum. The source and detector were then repositioned so that the same process could be repeated at 90 degrees to the original orientation. This process was carried out at both the upper and lower elevations.

If the riser was undamaged and in position, the density profiles should essentially be that of a smaller empty pipe (the riser walls), centered on, and superimposed upon a larger empty pipe (the drum walls). The scans indicated that the internal riser had in fact been broken off. The density profiles indicated that the top of the riser was leaning against the west wall of the drum, offset slightly to the south of the east-west centerline. Armed with this knowledge, process operations determined that with additional precautions they could continue operating the unit until the next scheduled shutdown.
