Trayed Column - Flooding Due to a Mechanical Obstruction

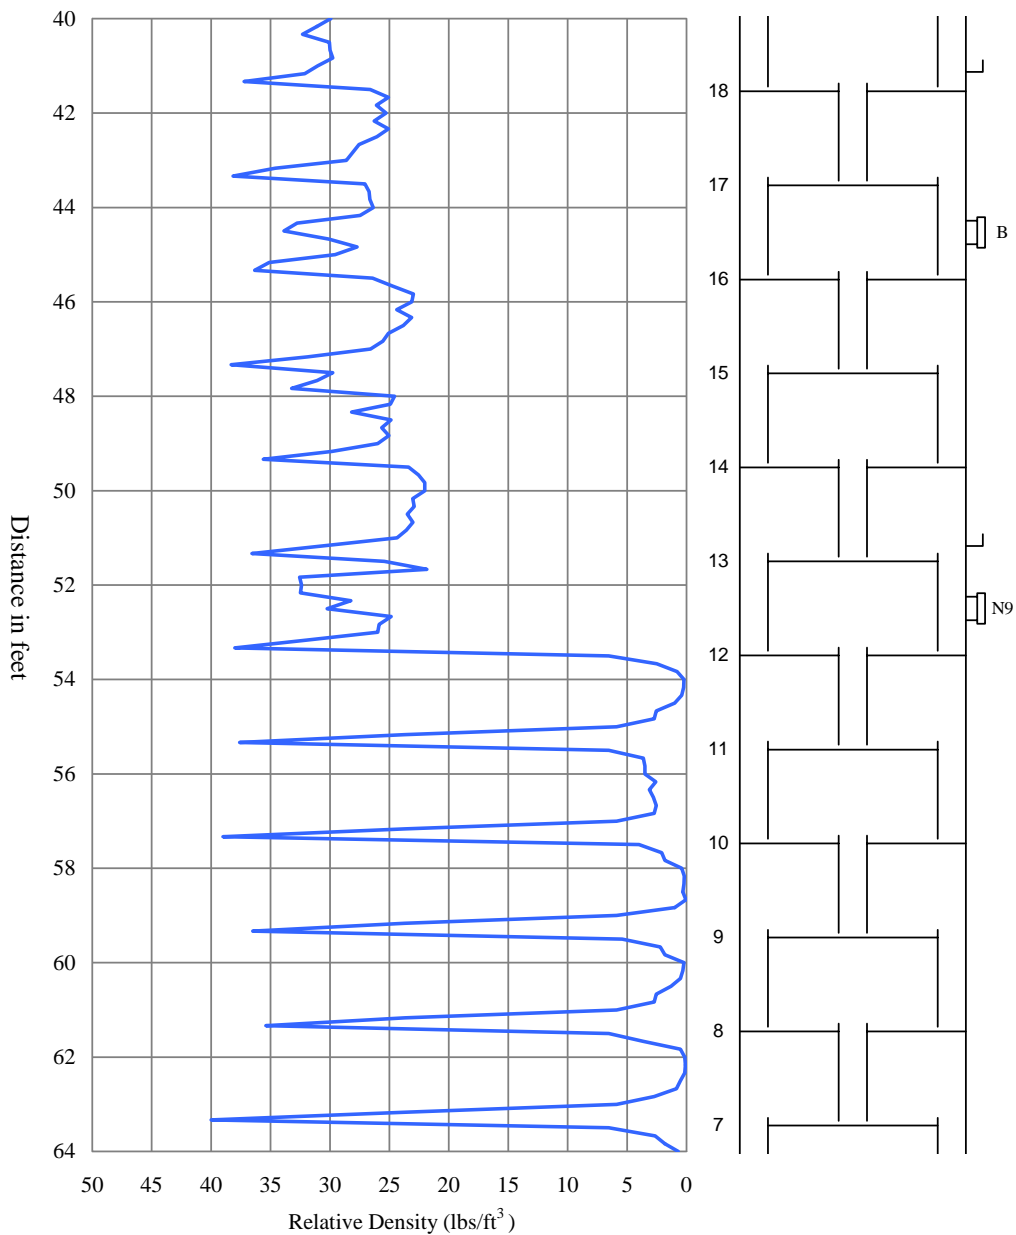
TowerScan Results: The scan revealed the tower to be flooded from tray 12 upwards. The sharpness of the transition from a flooded condition to a normally operating tower above and below tray 12 indicated an obstruction in the tray 12 downcomer. As the tower had a history of solids (salts) building up on the trays, the customer performed a water wash of the tower, after which the tower's operation returned to normal.

Example of a Mechanical Obstruction Resulting in Flooded Trays
